METAL FATIGUE OF MEMBRANE PLATE CONNECTIONS

An Installers Case Study

Bernard Hyde

Structurflex Limited
Auckland, New Zealand

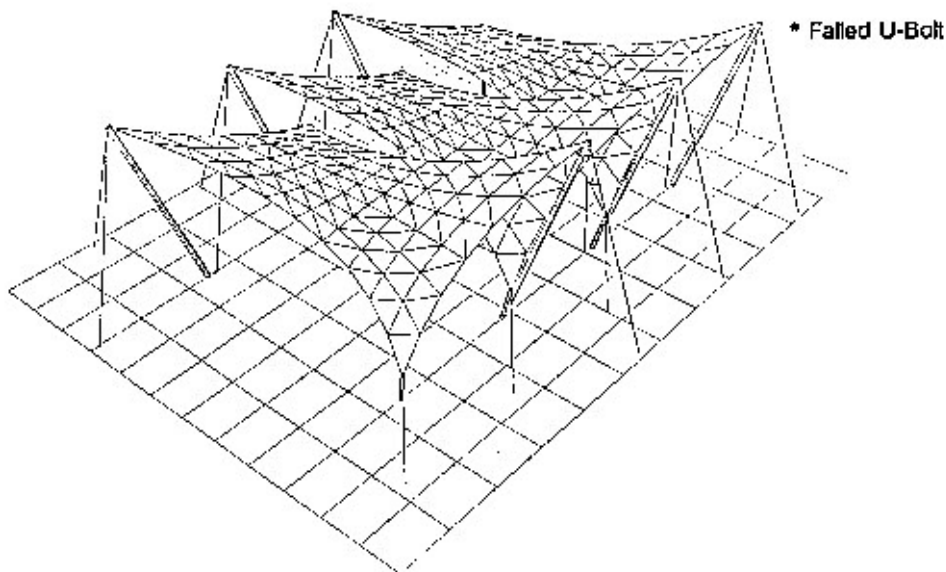
FIGURE A

- (Failed U-Bolt indicated on Figure A)
- The primary cause of failure was quite clear.

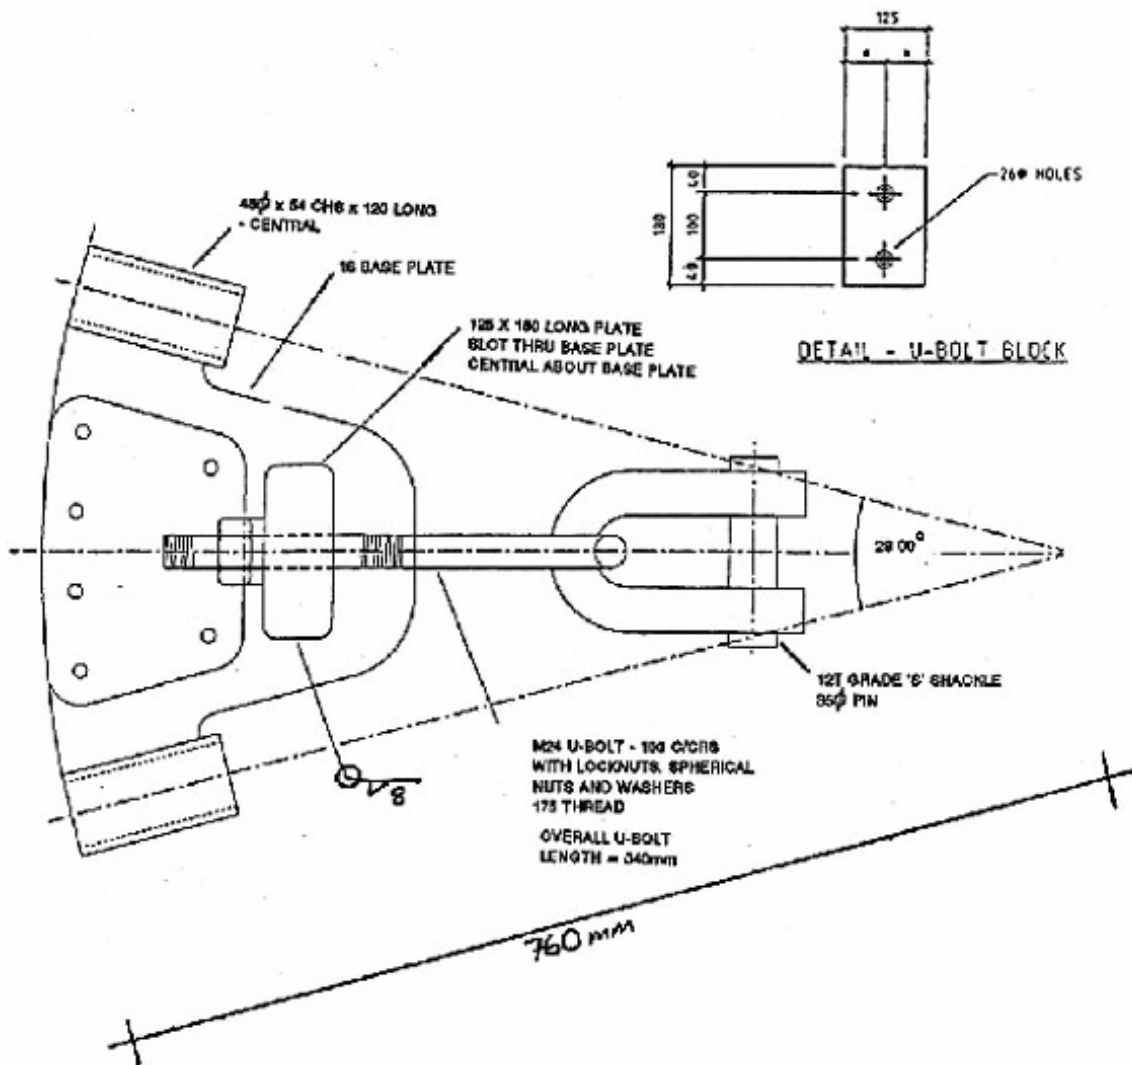
FIGURE C

In all cases the spherical nuts washers were not used. Refer figure C.

All of the above information indicates that the steel was the correct selection and in the correct condition to meet ISO Recommendation R898 Grade 8.8 category as shown on the drawing. Refer figure C

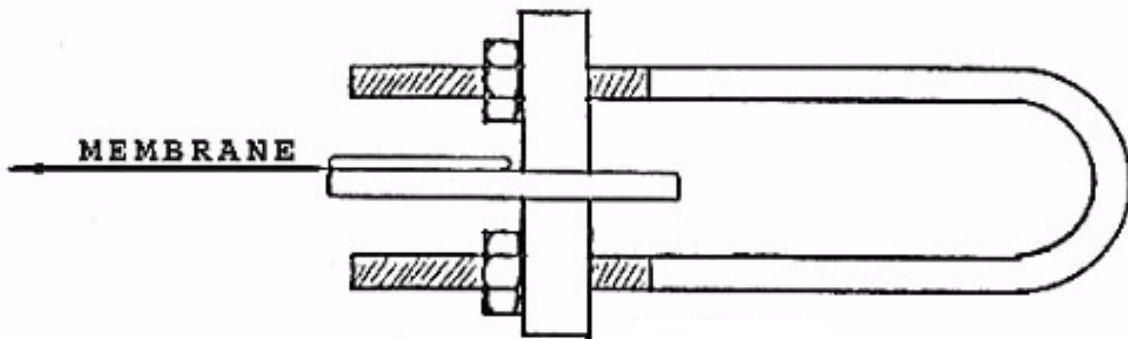
Figure E

- 235 days after installation completion a pedestrian heard the sound of a falling object hitting the ground (not far away!)
- The citizen reported this to the Principal Contractor.
- The Square surrounding the Hypars was immediately closed off.
- Temporary restraints were placed around the failed bolt.
- The bottom leg of the U-Bolt had failed.

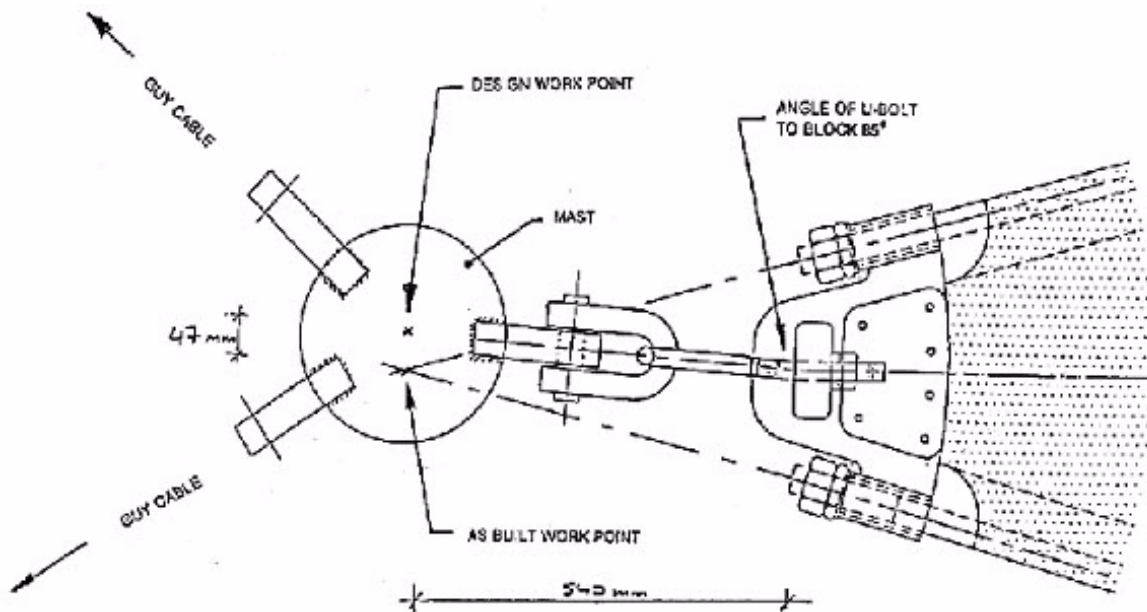
FIGURE F

- There was substantial mis-alignment of the membrane plate with the mast top connection point. i.e The U-Bolt was resting and bending on the edges of the U-Bolt Block. This was clearly a result from the initial set up of the structure.

6.1 Primarily the U-Bolt was working in "bending" caused by mis-alignment due to oversight at installation (Refer Figure F)

Design Rotation = $\pm 2.29^\circ$

Installation Rotation Set up = $\pm 5.0^\circ$

- As the new U-Bolt were replaced the masts were aligned so that they remained in the design plane, so that the U-Bolt in static condition was centralised through the block.
- Guy cable tension was then evenly applied until final prestress was reached.
- * Final check of all connection points for alignment

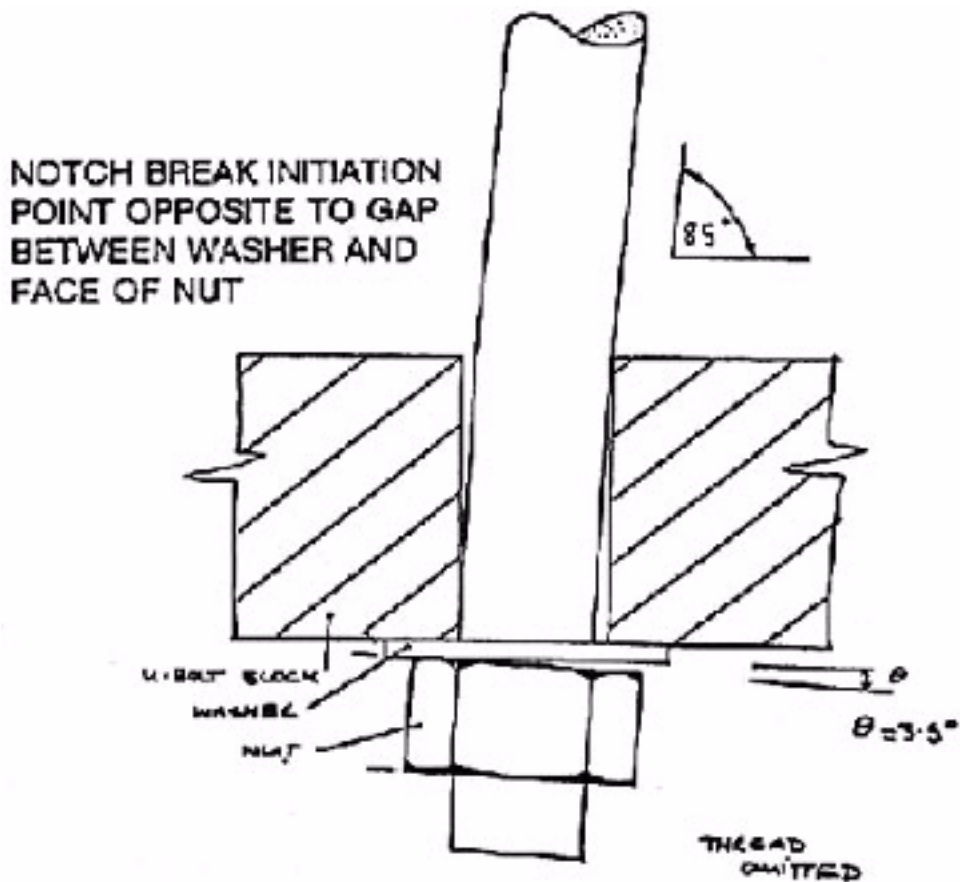
FIGURE G

After observing the failed U-Bolt and the other eleven it was clear that all had been mis-aligned. The failed U-Bolt more so. * Note – short mast membrane plates were out by $\approx 1^\circ$ as the single

guy cable allowed the mast to rotate into a more appropriate position. As opposed to the double guys of the long masts which would not allow any movement.

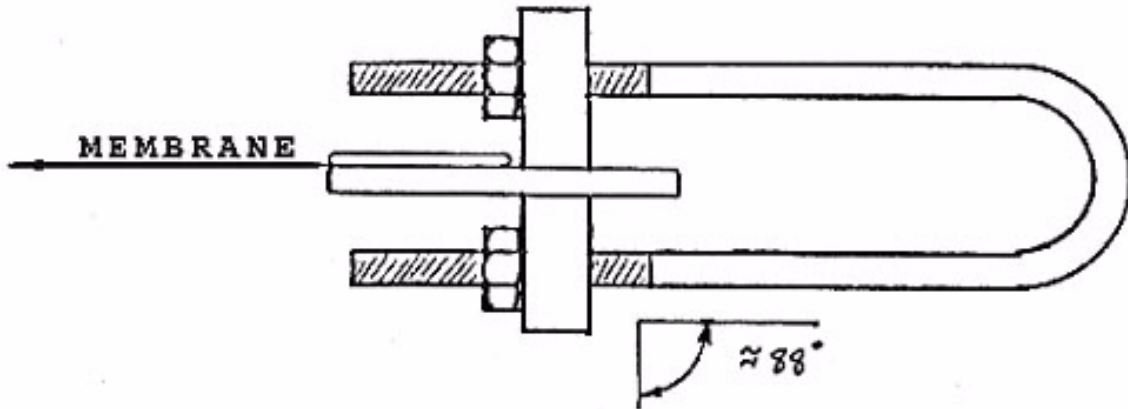
FIGURE H

NOTE: No inspection was performed during or after installation in terms of the membrane plate to mast alignment, or to the squareness of the membrane plate U-bolt block to the U-Bolt. (Refer figure H)

The broken bottom leg was due to the length of the U-Bolt not being adjusted evenly. Through the block i.e. more load on the bottom leg than top, hence greater fatigue on the bottom leg.

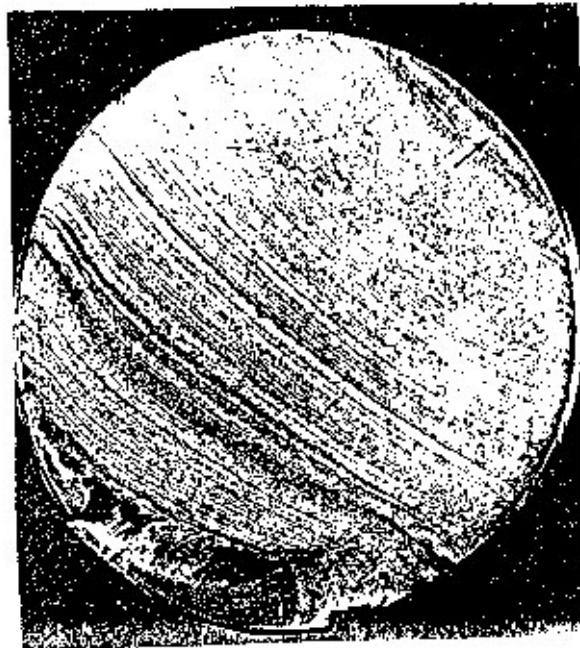
FIGURE I

The break was clearly a metal fatigue situation with a notch initiation at the thread root immediately below the nuts on the first thread turn at the bearing face of the U-Bolt Block.

* Arrow indicates notch initiation

- The crack initiation site was multi-positioned, at the root radius of the threads.
- This initiation site exhibited some seven "ratchet" marks approximately 40% of the total thread circumference.
- The fracture mechanics involved were fatigue-initiated with a multitude of fatigue striations across 60–70% of the surface area.
- The fatigue failure was of a unilateral bending type with indications of a low stress/high cyclic nature.
- The "critical area" left opposite to the crack initiation was about 20% of the total cross-sectional area. This corresponds to the critical stress involved in the final catastrophic failure under ductile conditions.
- The features of this failure were a good example of variable stress concentrations developed under bending loads on an area of high tensile stress created during high torque settings.

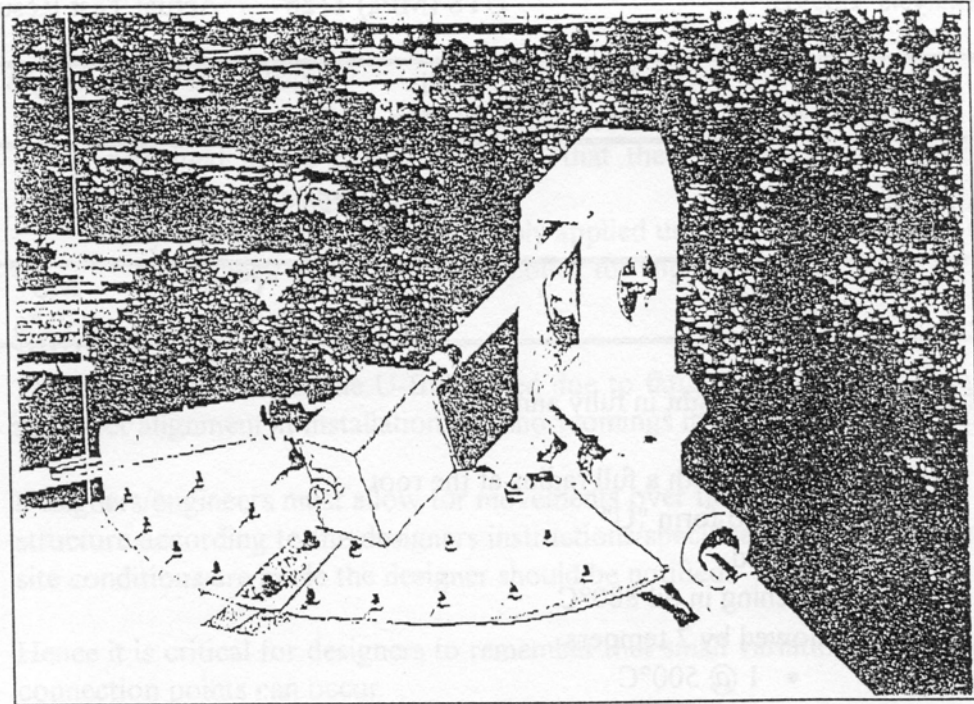
FIGURE J

As found with case study II a similar fatigue failure of a U-Bolt occurred, not caused by mis-alignment, but excessive fabric movement occurred under wind load due to fabric prestress not being achieved at installation. However the failure mechanisms were the same, except the notch break was at the front of the U-Bolt block this time.
