Lessons from a Recent Space Truss Collapse

Ariel Hanaor

National Building Research Institute, The Technion, Israel Institute of Technology
Technion City, Haifa 32000, Israel.

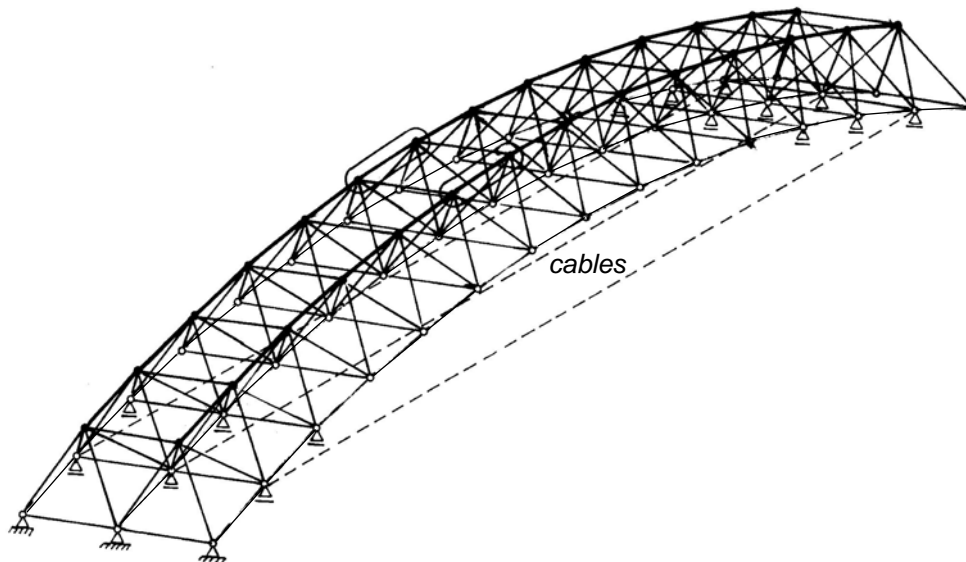
Figure 2: Schematic layout of space truss

shown in Figure 2, which in itself is unreasonable and unfeasible in the given site conditions. The analysis assumed concentric pin-jointed network, loaded at the nodes. The execution of all site work, particularly welding, was substandard and incapable of sustaining the design loads, which in any case could not be supported by the loose sandy clay soil of the embankments.

- Photographs of the bridge during lifting operations show only two top chord bars at mid-span severely damaged (marked in Figures 2 and 3). One of the bars (the west facing) showed a typical three-hinge beam failure mode. The other bar was ruptured at a weld at about third of its length. The longer part, having been detached during lifting, was found on the ground. Practically all top chord members and some of the other bars were made up of two and sometimes three pieces, by butt-welding.

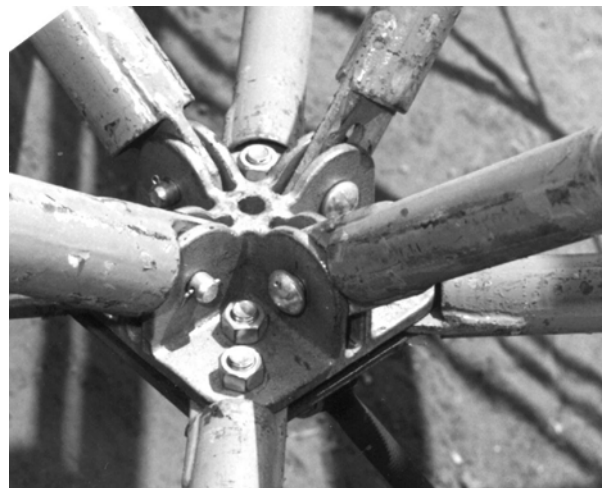
Figure 5: BEK joint

- The prevalent failure mode found on site, whether primary or secondary (due to removal operations) was rupture of bars at the fin-plates connecting them to joints (Figure 5) and severe joint rotations, similar to that of Figure 7. Top chord members, other than the two mentioned above, were generally undamaged, except for some slight bending.

- The diagonal members are connected to the joint by pins and there is substantial “free play” so that diagonals do not contribute anything to joint stiffness (Figure 5). Neglecting torsional stiffness of transverse chord members and associated fin plates, the total rotational stiffness of the joint is provided by two fin plates of opposing members. This capacity was calculated as 0.68 kNm for each top chord fin plate, or a total plastic capacity of the joint of 1.36 kNm (ignoring flaws observed in the welding of the fin plate to the tube, which would reduce the capacity further). Bottom chord joints’ capacity is even lower – approximately 0.8 kNm.

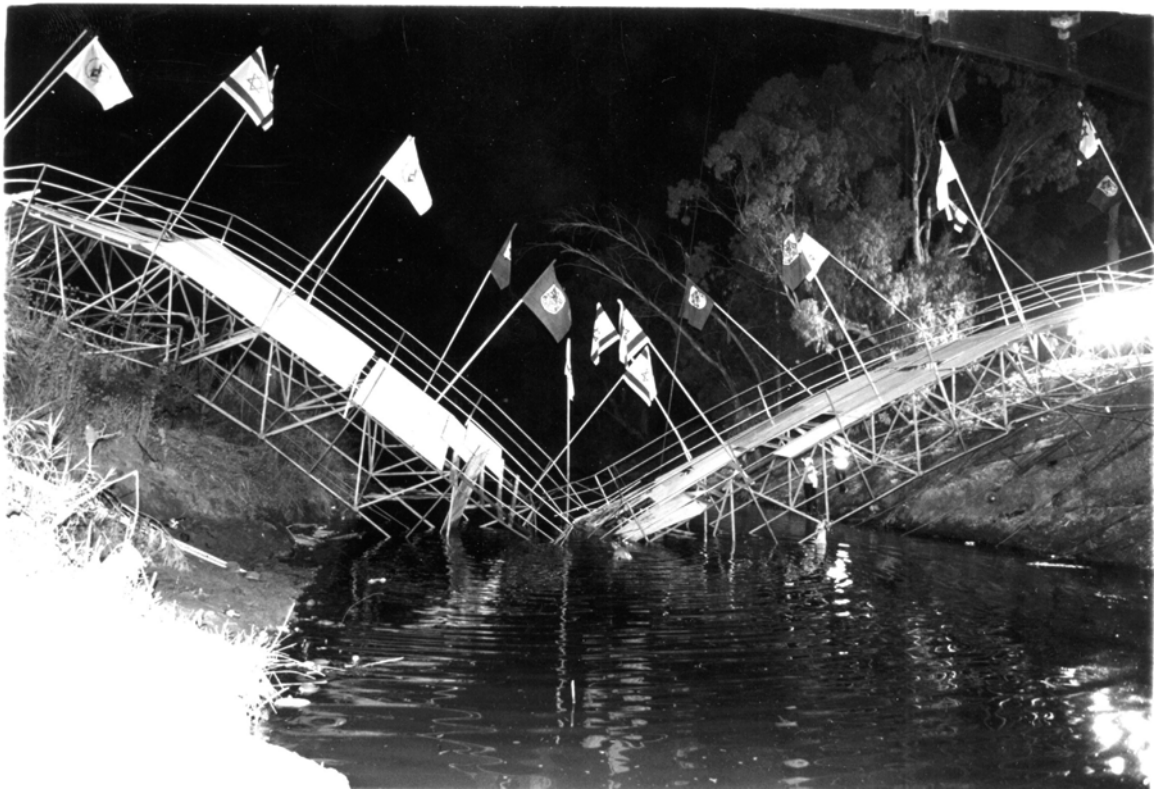
Figure 6: The collapsed bridge (Photo – Oren Agmon)

Although the eye-witness testimony is consistent in suggesting failure initiation at mid-span, it is clear from Figure 6 that failure took place both at mid-span and at the northern interior support joints. Whichever failure occurred first, it would be closely followed by the other, the mid-span drop being the more conspicuous. It is impossible to determine, which of the two central chord member failure modes took place first – rupture of the weld or joint instability (It should be noted, however, that an increase in axial force due to support settlement or rupture tends to stabilise the weld while destabilising the joint). In any case, from the point of view of design implications, the joint rotation mechanism is of particular interest and it is further analysed below.

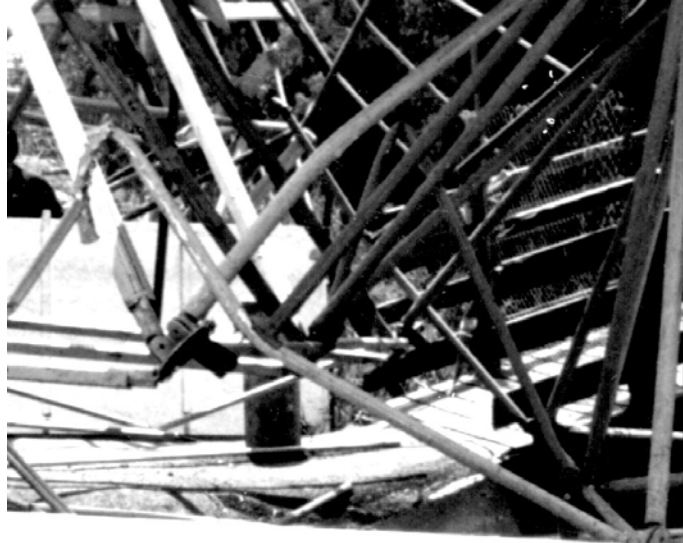
Figure 7: Support joint rotation

- Practically no members failed in buckling, in the normal way. Bending of some bars found on the site occurred during removal operations.
- The bottom chord did not rupture within the main span, although all three bottom chord members between the intermediate support and the inner support ruptured at the inner support joints (Figure 7).

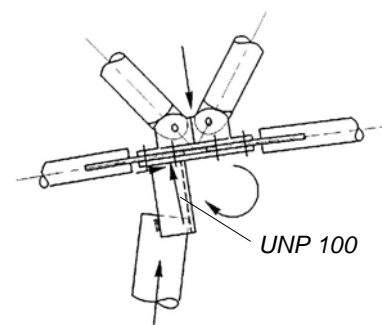
Figure 8: Interior support connection

❑ Failure of the connection of internal support column to the bottom chord joint by rupture of the weld and/or by joint instability. It should be noted that the support was attached to the joint eccentrically, exerting a rotational moment on it – Figure 8.

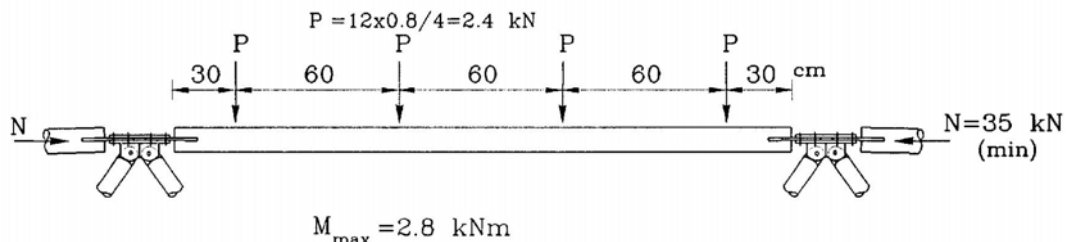
Figure 11: Loading of top chord member

- The top chord members were loaded along their length by the deck joists – Figure 11. This load causes hogging moment on the fin plates of connecting members, reducing their capacity to resist joint rotation. Furthermore, if adjacent panels are not equally loaded (as was the case), this load itself tends to rotate the joint (Figure 12).

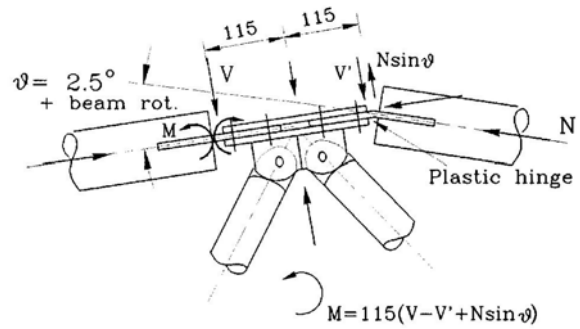
Figure 12: Top chord joint geometry and equilibrium.

- Worst of all: The joint is designed and manufactured specifically for flat square on square grids, forming regular pyramids (all members are of equal lengths). In this condition all members join concentrically. Introducing camber resulted in two negative effects:

One) Members are no longer concentric and unequal chord member forces on each side of the joint cause rotating moment on the joint;

Two) Members are manufactured straight, with straight fin plates. The camber is produced simply by top chord members being longer than bottom chord members by a specified amount. The angle change at each joint, required by the camber is produced by tightening

of the bolts at the ends of the framing members and bending the fin plates accordingly. Assuming this process is not carried out under tight control, it can be expected that the full required angle change (2.5° in this case) takes place in one of the two fin plates. In view of the short length of plate between joint hub and tube end (practically zero), this is sufficient to form a plastic hinge, leaving only one plate (at best) with any elastic stiffness reserve to resist any applied rotating moment. The combined effects of bending and eccentricity is illustrated in Figure 12 (rotation is exaggerated in the figure).
