Lightweight Structures Collapsed by Heavy Snow in January 1998 in Japan

Ken'ichi Kawaguchi

ABSTRACT

In January 1998, heavy snow have struck the Kanto and Koshin'etsu area in Japan. Three school gymnasiums in Yamanashi prefecture were collapsed under the snow load. The paper reports the damage overview of this snow disaster. Two of gymnasiums were collapsed by the snow fall and the third one was collapsed during rain, which was falling on three days after the snow fall and penetrating into thick snow on the roof.

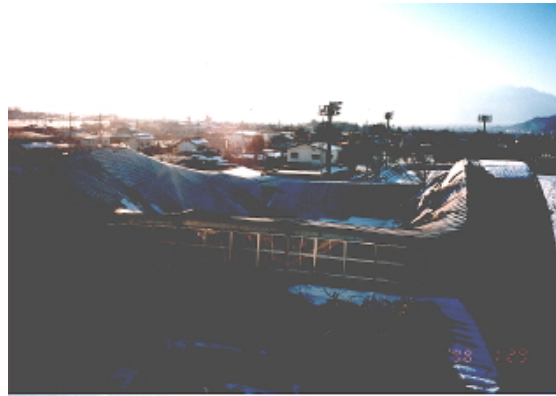
Neighbors who heard the large crash became aware of the collapse and informed to the school. The structure of the gymnasium was steel trussed arch assembled with light channel steels. Four spans in the middle part were collapsed while two spans near to both end walls stood still. Bolts connecting bottom chords at the center of the arch girders were broken off by shear (photo 3). Bottom chords of the girder ends or inner chords of the column tops were buckled (photo 4 (a), (b)). With these failures, whole of a single frame collapsed in mostly M shape (fig. 3(d)). Since snow on the roof moved to lower place, the inner two spans in the middle part, which were further from the end walls, were most heavily damaged. For these two frames buckling of inner chords of columns were observed (photo 4 (c)). Some of the bases were rotated as the frame deformed.

(b) After collapse

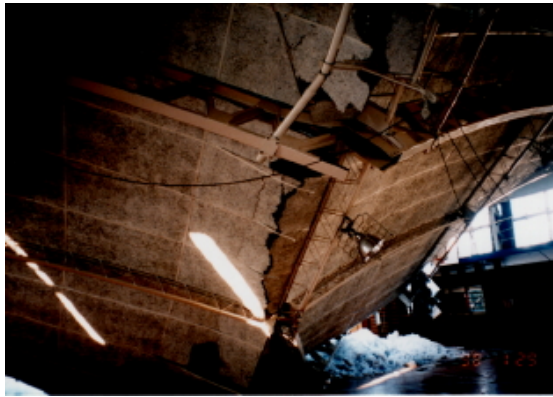
Photo 2: Interior view

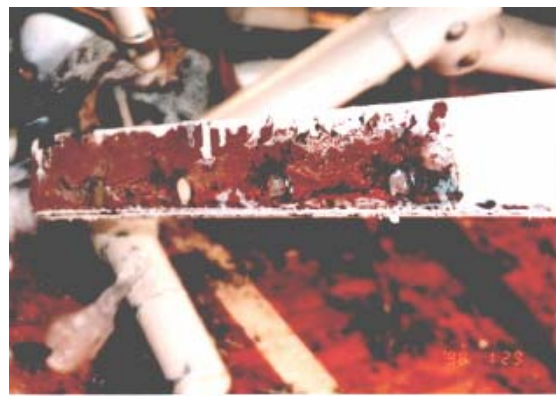
Photo 3: Shear cut of the center connection

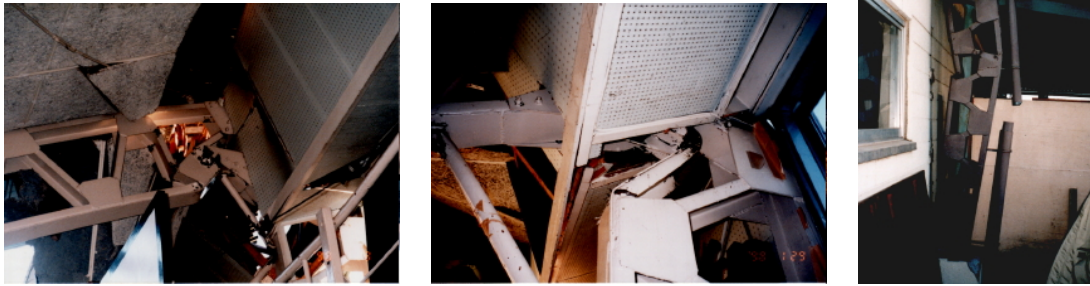
Photo 4: Failure at some positions

(a) End of the girder (b) Top of the column (c) Buckling of the column

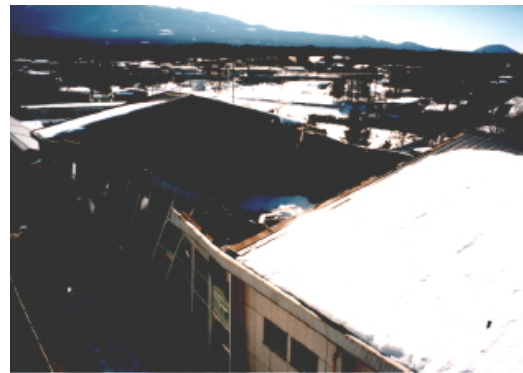
During the snow strong wind was blowing at this area. As same as the previous case, neighbors who heard the large crash became aware of the collapse and informed to the school. The structure of the gymnasium was low V shaped steel hinged arch assembled with thin prefabricated steel I-beam. The depth of the beam varies along the span and takes the smallest depth at the quarter of the span. The beam-column connection is a bolt connection using a special cross shaped steel element. Among nine span frames four spans in the middle part were completely collapsed while remaining five spans covering a stage and storage adjacent to end walls survived without any damage. Plastic hinges were observed just next to the beam-girder connections located at one third of the span from either side. By large torsional buckling columns were deformed from their tops to where the gallery floors were attached. Such failure formed mechanisms for collapse. Bolts at the bases were badly corroded, so that some of the bases were rotated and pulled off from the anchor bolts.

(b) After collapse

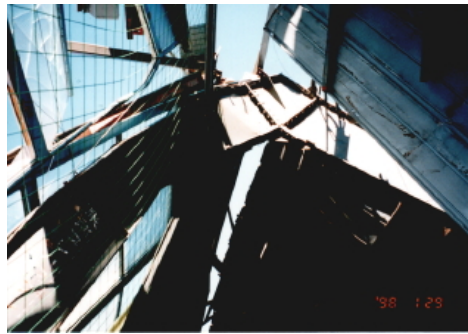
(a) Column torsional deformation

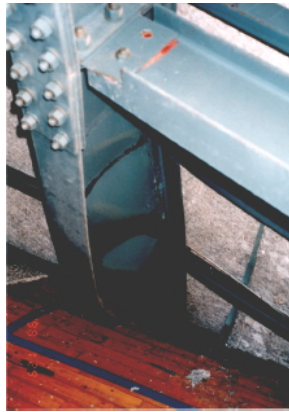
(b) Plastic hinge

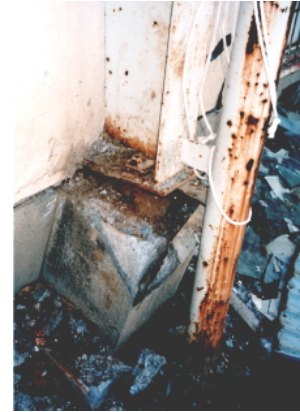
(c) Base and anchors

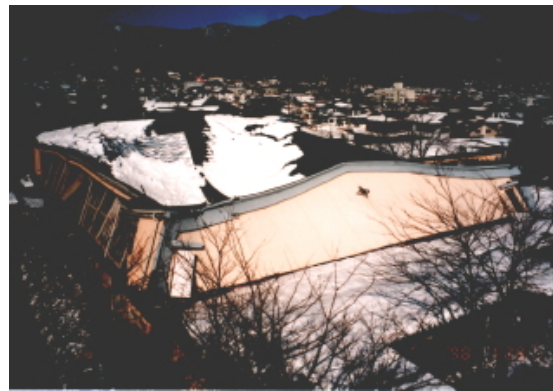
This structure did not collapse during snow on 15th. It rained from 17th through 18th and the structure collapsed in the morning of 18th. Again Neighbors found the collapse and informed to the school. From the foundation to the gallery level the structure was made of reinforced concrete. The upper structure was low V shaped hinged steel arch. The beam-column connection was prefabricated as one unit. Four spans in the middle part were collapsed while two spans of both end walls were not collapsed and leaned inside being pulled by beams connecting end wall frames to the inner collapsed frames. For collapsed frames plastic hinges were observed at the connection with beams located at one-third of the span. Other plastic hinges were observed at the ends of girders or at the tops of columns. Bases on the R.C. galleries were forced large rotation and all anchor bolts were broken off.

Thick snow on the roof absorbed rain. The rainfall on 18th was of 30mm, which is equal to the distributed load of 30kgw/m².

(b) After collapse

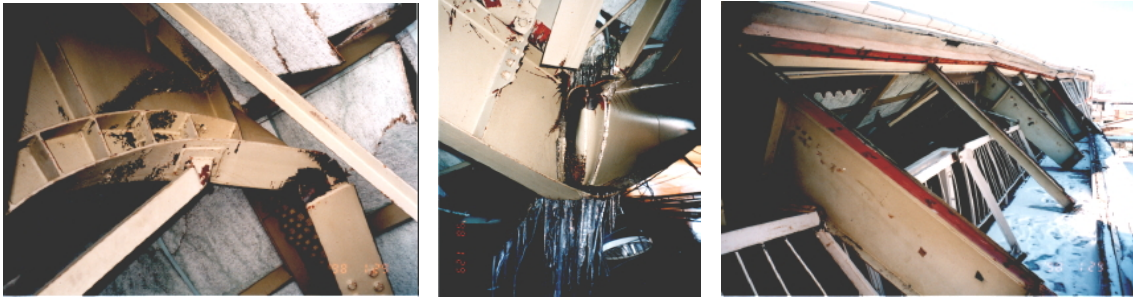
Photo 10: Failure at some positions

(a) Girder torsional deformation (b) Plastic hinge (c) Rotated columns and bases

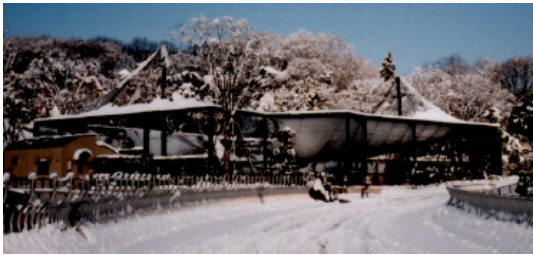
During snow on 8th through 9th a cable net roof for a flamingo birdcage in a zoo at Tama area of Tokyo was broken. The dimension of the roof was 36m x 13.3m. Main cables were 9mm diameter and spanned 28m between two main poles of 12m high. The net was fish net with 40mm x 40mm square grids. Such grid of the net is fine enough for snow to lie on. One of the main poles was buckled under the snow load.

(a) General view

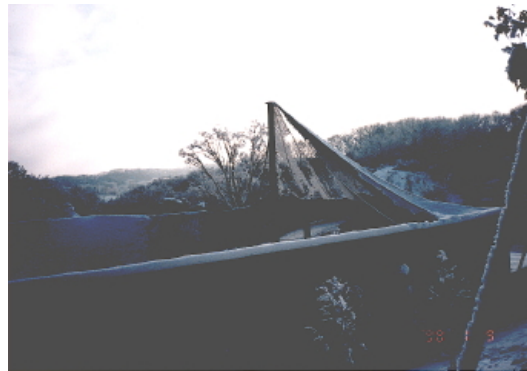
(b) Broken nets and a main pole
