METAL FATIGUE OF MEMBRANE PLATE CONNECTIONS

An Installers Case Study

Bernard Hyde

Structurflex Limited
Auckland, New Zealand

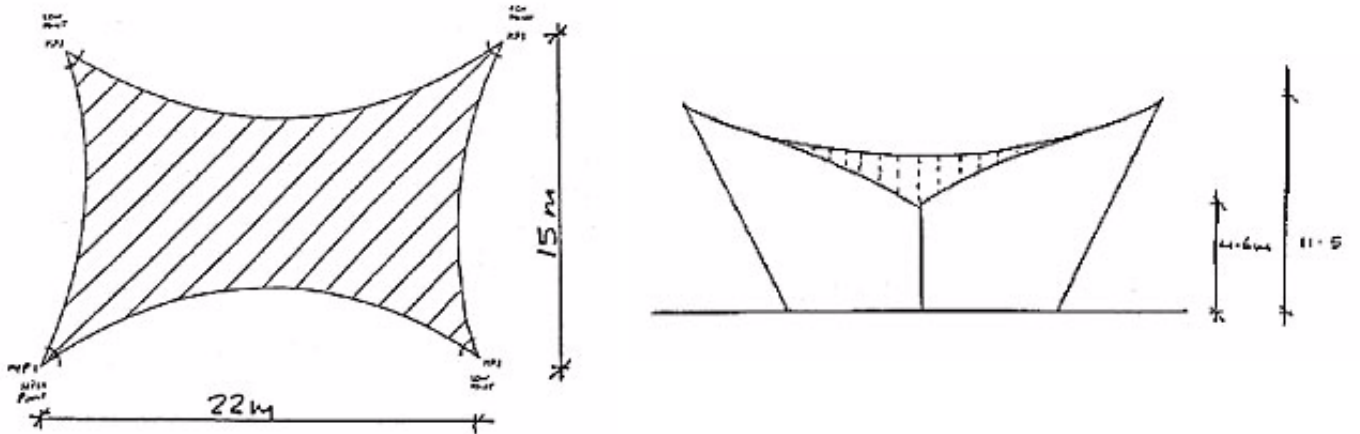
FIGURE B

Structure Type	=	Hypar
Fabric Type	=	Type II – P.V.C coated, with Polyester Base Fabric
Fabric Prestress	=	2KN/m
Guy Cables	=	28 ϕ 1 x 19 Galvanised with rigging screws
Catenary Cables	=	18 ϕ 1 x 19 Galvanised with swaged stud ends
