Lessons from a Recent Space Truss Collapse

Ariel Hanaor

National Building Research Institute, The Technion, Israel Institute of Technology
Technion City, Haifa 32000, Israel.

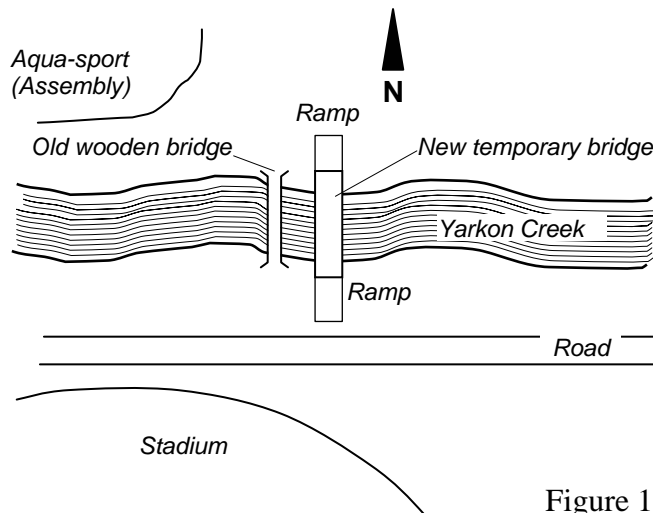
Figure 1: Site layout

On the evening of July 14, 1997, a temporary footbridge carrying athletes to the opening ceremony of the 15th Macabia sporting event in Israel collapsed, killing one person, injuring 60 and leading to the subsequent death of three more. All casualties were members of the Australian athletic team. The 34 m long bridge, spanning 25 m collapsed under a load of no more than one hundred people, even though the design called for four-fold this load. The general layout of the site is shown in Figure 1.

The truss was fully constructed on the north bank (Figure 1) and then lifted into position on site and the supports were adjusted and site welded to the truss and to the base plates.

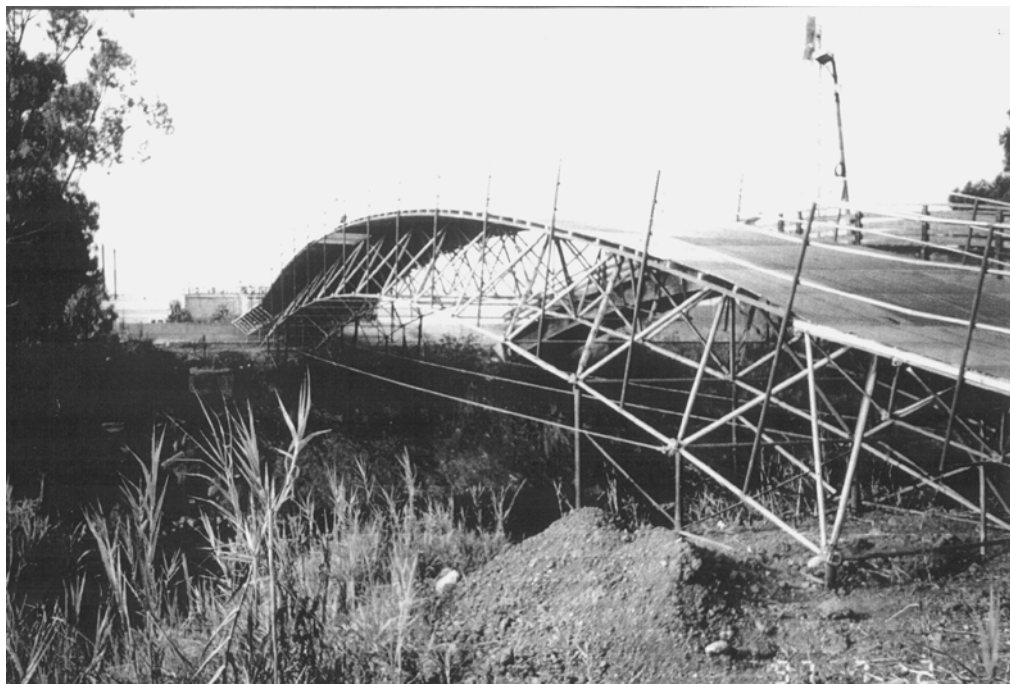
Figure 4: The constructed bridge viewed from the north bank

The 5 m wide plywood deck was supported on 5-by-10 cm timber joists spaced approximately 60 cm apart, so that three joists bear along each top chord member (figure 11). Since the top chord consisted of one module, 2.5 m wide, the joists overhung the top chord members by 1.25 m each side, and their edges were supported on an angle section which formed part of the parapet system. This system was vertically supported at mid-panel of the outer bottom chord members and horizontally tied to top-chord joints. The constructed bridge is shown in Figure 4.
