## The Amazon Waterlily Pavilion, Botanic Gardens Adelaide

Niko Tsoukalas, Principal, Aurecon Pty Ltd, Adelaide

Jennifer Macdonald, Structural Engineer, Aurecon Pty Ltd, Adelaide

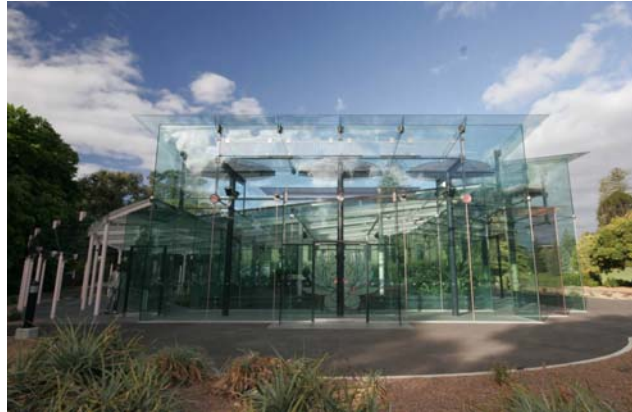
**Figure 1** *The New Amazon Waterlily Pavilion*

The new Pavilion features load-bearing glass columns and beams, and was completed in July 2007.

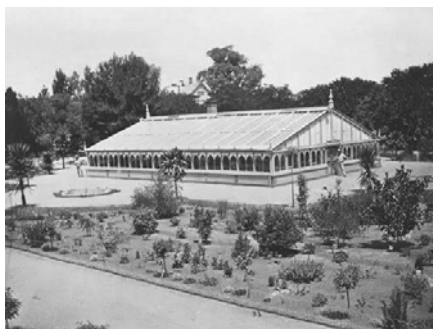
**Figure 2** *Photographs of the Original Victoria House (from National Library of Australia and Department for Environment and Heritage (DEH))*

The 1867 timber-framed superstructure of the original Victoria House had been replaced by an aluminium structure in the 1950s and this was in a dilapidated condition in 2005. The decision was thus made to replace the superstructure with a modern glass Pavilion, whilst preserving the original heritage-listed lily pond in the centre of the structure.

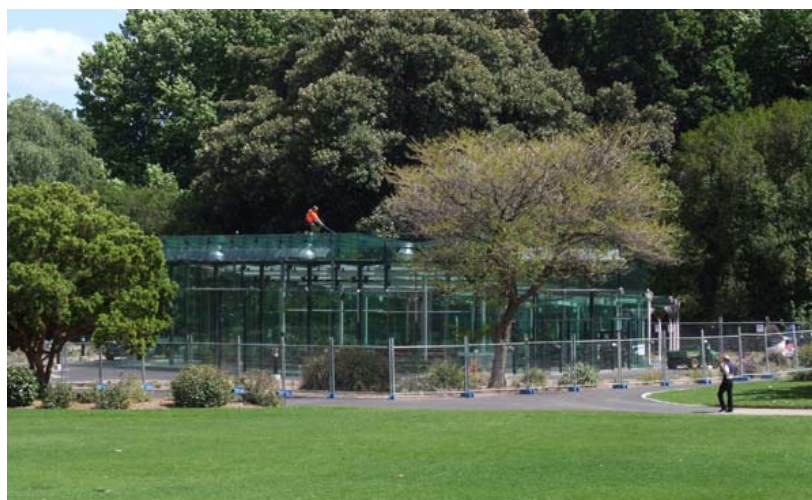
**Figure 5** *Construction Worker Cleaning Glass Roof – Viridian 'Activ' Coating will reduce the frequency by which this is required (photo Jeremy Prentice, DEH)*

State-of-the-art finite element analysis (FEA) software was employed to analyse every unique panel; glass has no ability to yield and the effects of stress concentrations and lack-of-fit at bolted connections cannot be ignored by engineers in this specialist field. Using FEA, Aurecon was able to reduce the thickness of the roof panels from the concept phase depth of 20mm down to 16mm; a sufficient saving to enable the client to purchase glass with a self-cleaning coating, thus reducing both maintenance costs and reliance on cleaning chemicals.

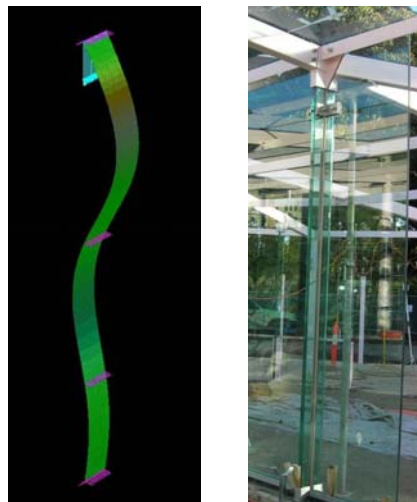
A safety factor of 3 was considered appropriate for the beams and columns. This was achieved using triple laminated glass, with each separate lamina of the beams designed to support serviceability loads until replacement can be effected. The glass columns comprise a central 19mm toughened core layer, with 10mm 'sacrificial' layers either side. The 10mm layers will provide scratch protection to the central core, and the 19mm layer can support serviceability loads (these columns provide support to the sloping steel-framed portion of the side roof). The columns were analysed using Strand7 to determine maximum stresses and also to carry out a buckling analysis, as they were originally intended to be free-standing. For the final design, glass panels were incorporated either side, which provide additional restraint against buckling.

**Figure 6** *Glass Column - buckling analysis in Strand7 and final installed photograph*

The authors are not aware of any other public buildings in Australia that feature structural glass columns and beams. These are possibly the most unique features of the Pavilion project. As the columns and beams are critical load-bearing elements in the structure, it was important to consider redundancy and prevention of disproportionate collapse in their design.
